# ASSESSMENT OF TAILINGS MANAGEMENT FACILITY

## Evaluation of geochemical and hydrological impacts from a phosphogypsum stack

Gipsön, Landskrona, Sweden

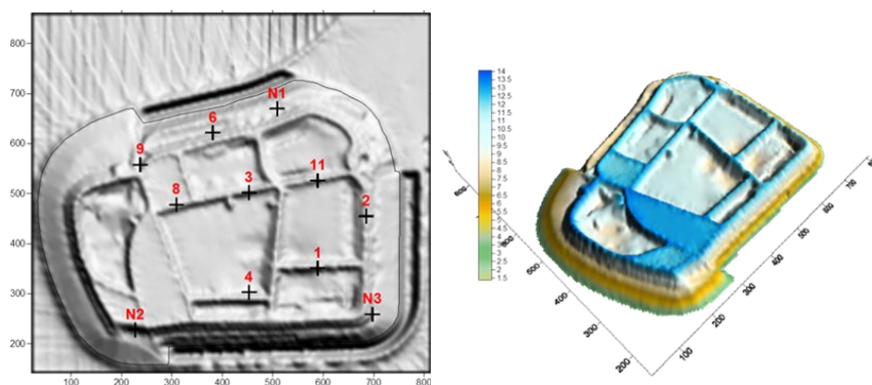
A digital elevation model, including the location of sampling points (left), was set up in order to calculate the groundwater volume at the site. © DHI

We estimated the amount of residual pollution present in the groundwater at the disposal site. This is the amount of pollution that can potentially affect the surrounding environment. We then used Surfer® to calculate groundwater volume and pollution levels. In addition, we estimated the amount of chemicals needed for neutralisation of the leachate from the site. This was vital information for YARA AB with respect to future leachate treatment. We were able to provide this information by combining test data derived in our laboratory and data from a modelling exercise carried out in PHREEQC.

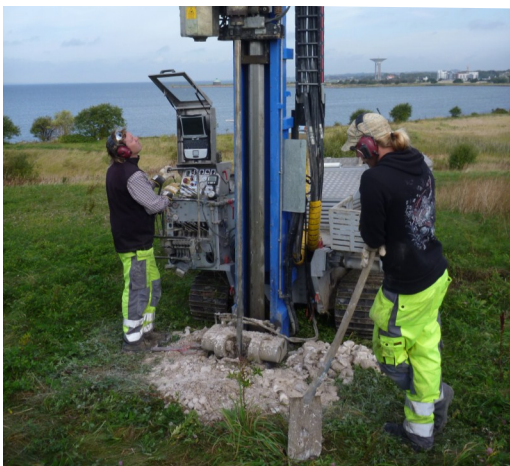
Images from sampling at the phosphogypsum stack, Gipsön, Landskrona, Sweden. ©DHI

First, a third party contractor performed drilling at Gipsön to extract groundwater and gypsum samples from the disposal site and collected leachate samples. We then sent the samples to another contractor, who conducted a chemical analysis for a full spectrum of elements.

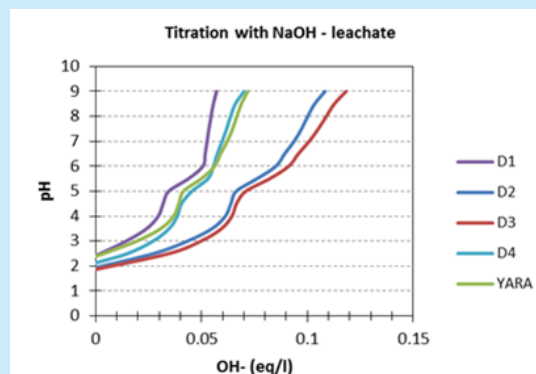
Calculated titration curves. © DHI

We operate an environmental laboratory in Hørsholm, Denmark. Our laboratory and testing facilities enable us to carry out routine tests as well as specialised and tailor-made tests for our clients. This allows us to generate site specific data when needed. For this project, we carried out the proper handling and treatment of samples taken at the disposal site, before handing them over to the chemical laboratory. Our titration experiments provided YARA AB with valuable information on resources that would be used for future leachate treatment at the disposal site.
