DHI CASE STORY

PROTECTING SINGAPORE'S MANGROVE FORESTS

Using EMMP to determine the impact of construction works

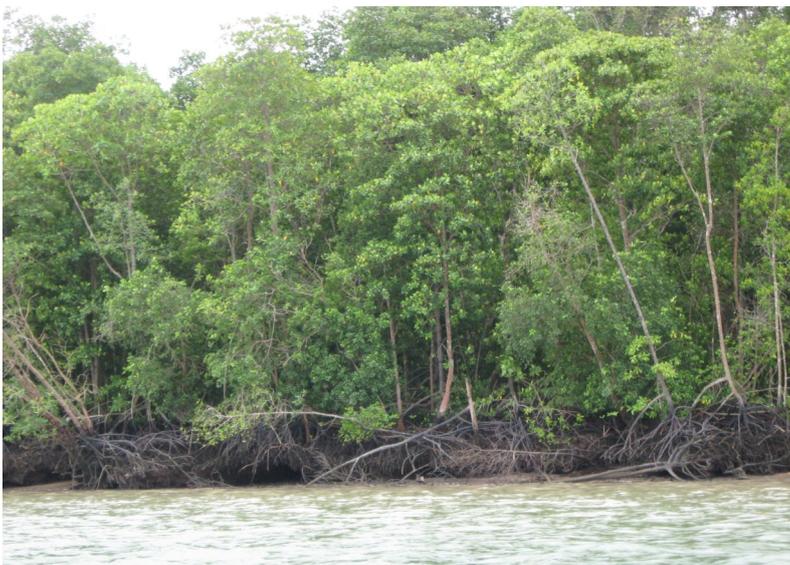
Erosion of the mangrove shoreline at Tekong Island prior to stabilisation of the shoreline on the island

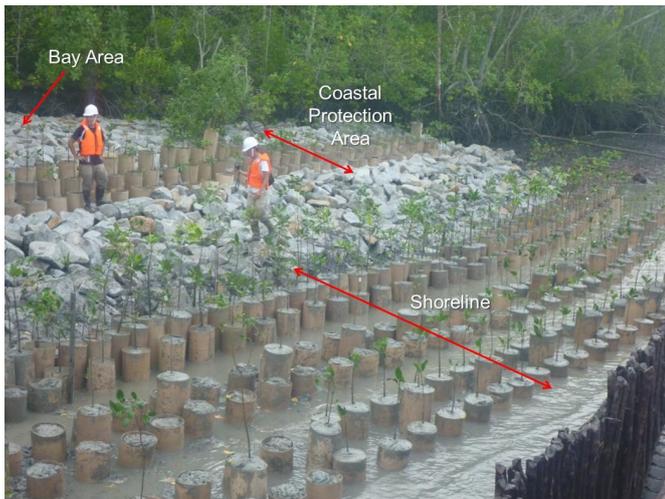
Photo of the shoreline after construction of the shoreline stabilisation measures showing our monitoring team
